SEISMIC HAZARD IN TAKAMATSU JAPAN

Shuichi HASEGAWA, Minoru YAMANAKA, Hitoshi OHTA

ABSTRACT: The harbor city Takamatsu has population 420,000 and situated on the northern shore of Shikoku Island, southwest Japan. Downtown of Takamatsu is located mainly on delta and fill-up lands and was extensively damaged by storm surge due to No.0416 typhoon in 2004. Earthquakes in the Nankai Trough, typically of magnitude more than M 8, have been extensive damaging to the city every hundreds years and the next one is expected to occur before middle of 21st century. Deltic deposit of downtown of Takamatsu is composed of the Holocene sandy sediments. The reclaimed lands are composed of unconsolidated sandy and silty sediments, dredged soils and waste materials. Therefore, liquefaction and successive tsunami of 2m+ are the serious threat to the city. This paper estimates the seismic hazards in Takamatsu from the study of past disasters and liquefaction risk by the help of geo-informatics.

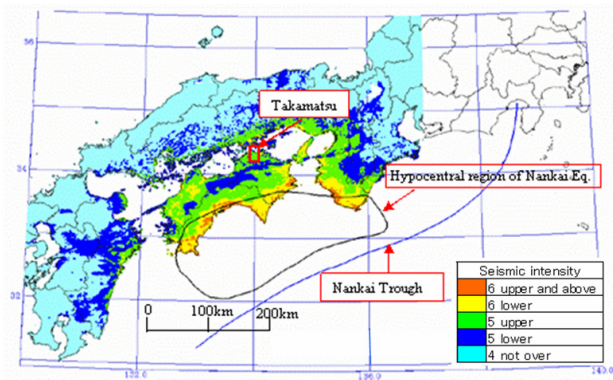
Figure 1. Estimation of seismic intensity for future Nankai Earthquake (modified from Central Disaster Prevention Council, 2003)

Takamatsu is situated on the northern shore of Shikoku Island, southwest Japan. Shikoku Island is situated on the Eurasian Plate. About 120-180km from south coast of Shikoku, the Philippine Plate is subducting beneath the Eurasian Plate along the Nankai Trough. Earthquakes in the Nankai Trough, typically of magnitude M 8+, have been considered the primary source of seismic hazard for the island and Takamatsu. Takamatsu has suffered serious damage by the Nankai Earthquake in past. The Headquarters for Earthquake Research Promotion (2005) estimated that the probability of the next Nankai Earthquake is 50% within 30 years from 2005, and it is 80% within 50 years. Estimation of seismic intensity of future Nankai Earthquake is shown in Figure 1.

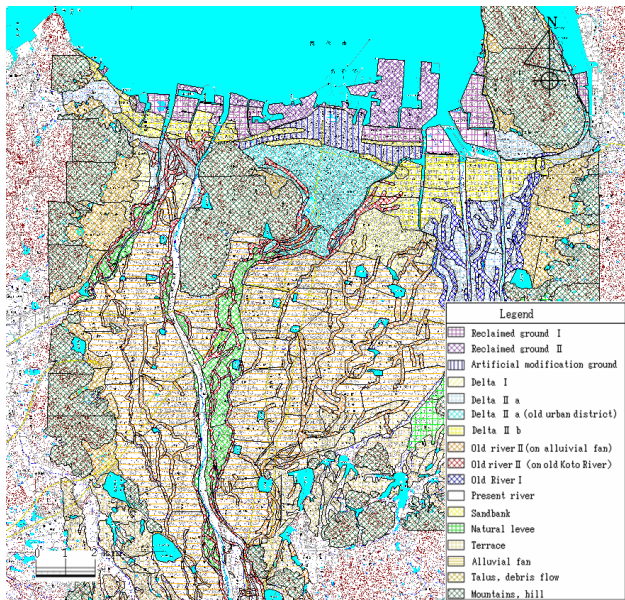
Figure 2. Micro-topography of Takamatsu Plain

Downtown of Takamatsu is located mainly on delta and reclaimed lands, and urban areas are developing on the fan of Koto River and the flood plain of other rivers (Figure 2). As the ground level of delta and reclaimed lands is usually below 3m, tsunami caused by Nankai Earthquake and flood storm surge by typhoon are great threat to Takamatsu city. In addition, earthquake shaking can be easily simplified in delta and reclaimed lands, thus the city has great risk of liquefaction. Therefore combined research on earthquake tremor, liquefaction and tsunami is necessary to estimate the seismic hazards associated with future Nankai Earthquake.

The Takamatsu plain is mainly composed of the alluvial fan of the Koto River, the subordinate flood plains of the Shin, Kasuga and Honzu Rivers, deltas of these rivers, and landfills along shore (Figures 2). Downtown Takamatsu is mainly located on deltaic deposits and the urban area is developing on the fan of Koto River, flood plains of other rivers and reclaimed lands.

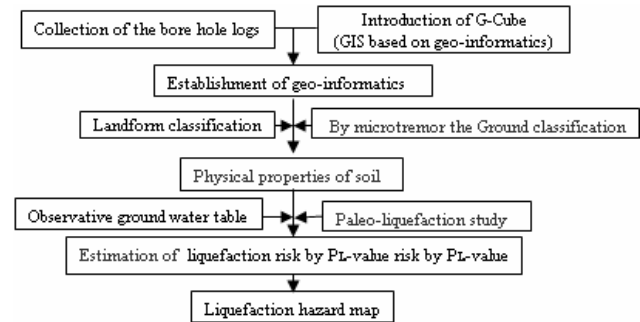
Figure 3. Flow chart of the research

The objective of this study is to estimate the seismic hazards in Takamatsu from study of past disasters and liquefaction risk by the help of geo-informatics. First we have developed geo-informatics by using G-Cube (Integration Ground Information Management System by Chuo Kaihatsu Co., Ltd.) and about 1,500 borehole logs are registered into the geo-informatics. The ground conditions are classified into three categories by the help of micro-topography and microtremor

observation. The liquefaction risk is also estimated on the basis of P_L -value (Figure 3).

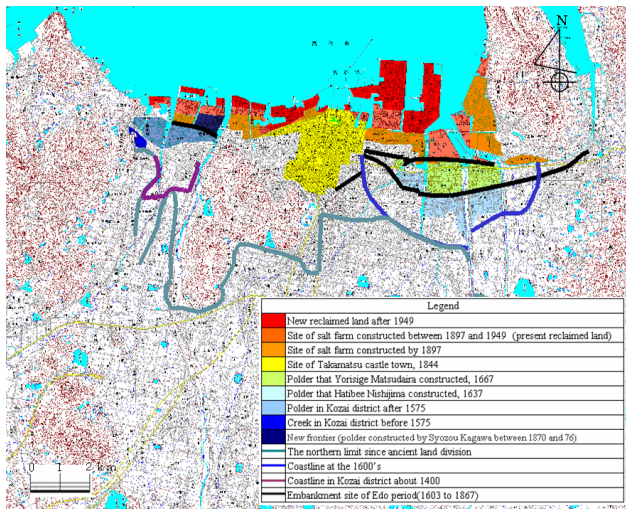
Figure 4. History of land use on Takamatsu Plain

Reclaimed lands have been developed for paddy fields and salt pans since the 17th century and salt pans were filled up in 1970s (Figure 4). These area are composed of soft sandy deposits, dredged soils and waste materials.

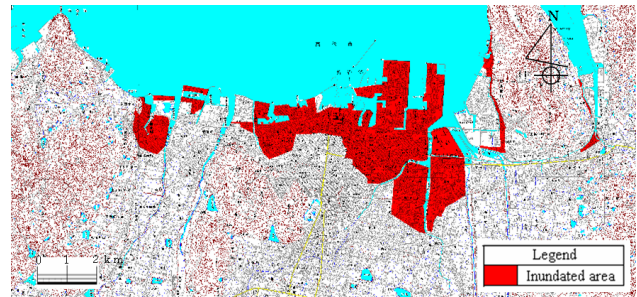
Figure 5. Inundated area by storm surge due to Typhoon No.0416 in Takamatsu (modified from Takamatsu city, 2004)

Typhoon No.0416 caused storm surge disaster on Aug. 30th to 31th. Storm surge at Takamatsu harbour recorded 2.46m above sea level, which have exceeded past record to 0.64m. As the height of most revetment around Takamatsu port have been designed to be only 2.05m, sea water flew into the downtown area and about 15,600 houses were inundated. The inundated area by Typhoon No.0416 (Figure 5) is almost same inundated area by Nankai Earthquake tsunami estimated from Kagawa Prefecture (Figure 6). This indicates that the Nankai Earthquake tsunami will cause severe damage in downtown Takamatsu.

The tsunami flood hazard map (Figure 6) and high tide flood area (Figure 5) clearly shows that the reclaimed lands for paddy fields are lower than new landfill area near the shore. This topography will cause deeper and longer inundation in the past reclaimed paddy field area and will cause destructive damage by next Nankai Earthquake tsunami.

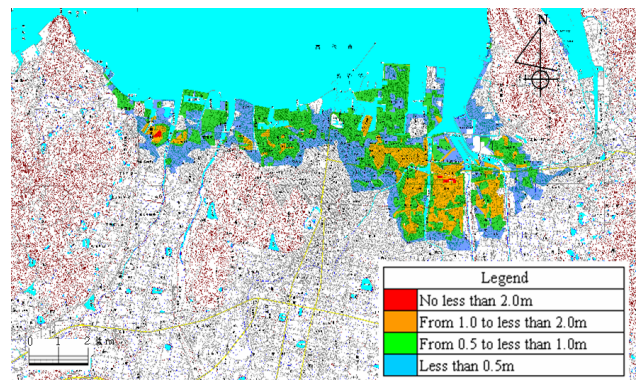
Figure 6. Flood area by Nankai Earthquake tsunami estimated from Kagawa Prefecture (2004)

Downtown Takamatsu is composed of Holocene sandy deltaic sediments. Reclaimed lands are composed of soft sandy and silty deposits, dredged soils and waste materials which have very high risk of liquefaction (Figure 13) and amplification of tremors (Figures 10 and 11). Unfortunately almost all seawall and bank have designed neither as earthquake proof nor to deduce liquefaction. Therefore, liquefaction and successive tsunami (2m+) (Figure 6) are a serious threat to the city near shore.

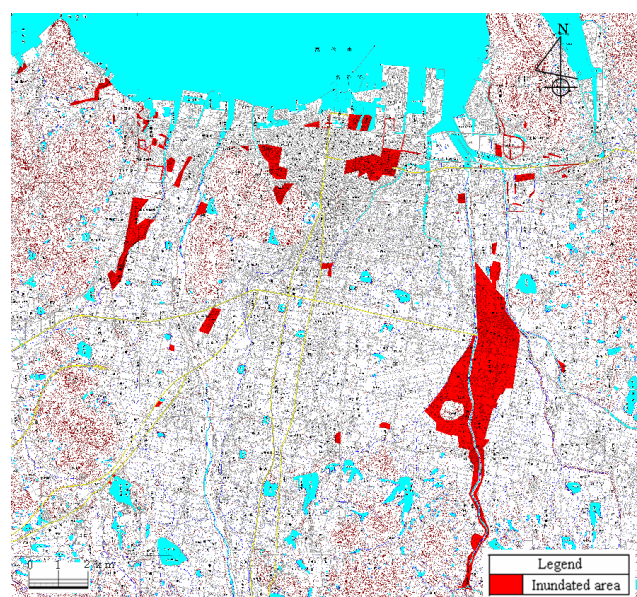
Figure 7. Inundated area by Typhoon No.0423 in Takamatsu (modified from Takamatsu city, 2004)

Typhoon No.0423 caused flood along the Kasuga and Honzu rivers on Oct. 20th and about 5,600 houses were inundated (Figure 7).

The liquefaction hazard map (Figure 13) and inundation map by typhoon No.0423 (Figure 7) also suggest that inundated areas and their vicinities are highly liquefiable and have possibility of inundation

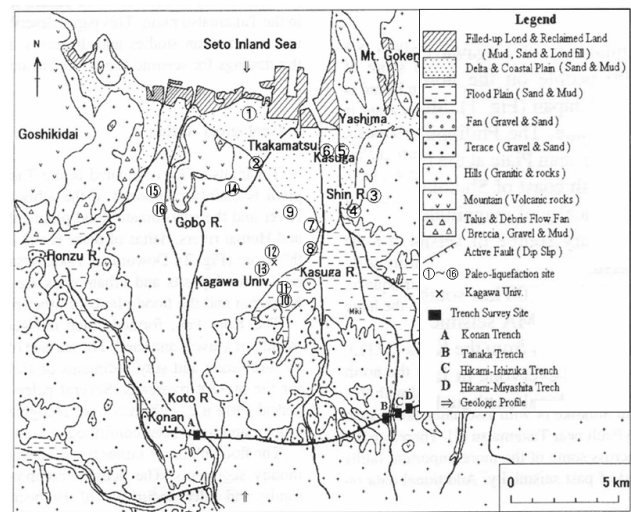
Figure 8. Outline of topography of Takamatsu area including liquefaction sites

The 16 paleo-liquefaction sites in Takamatsu plain have been reported by archaeologist (Kinoshita, 2000, and Oshima, 1996). According to these reports, the 9 sites of the paleo-liquefaction are located on the Koto Fan and 7 sites are located on the delta (Figure 8). It is interesting to note that the paleo-liquefaction sites are concentrated on the eastern part of the Koto Fan. Detailed survey of micro-topography and archaeology have demonstrated that most of the paleo-liquefaction

sites are located along the paleo-channels in reclaimed land or marshes on the fan(Hasegawa& Finn,2002).

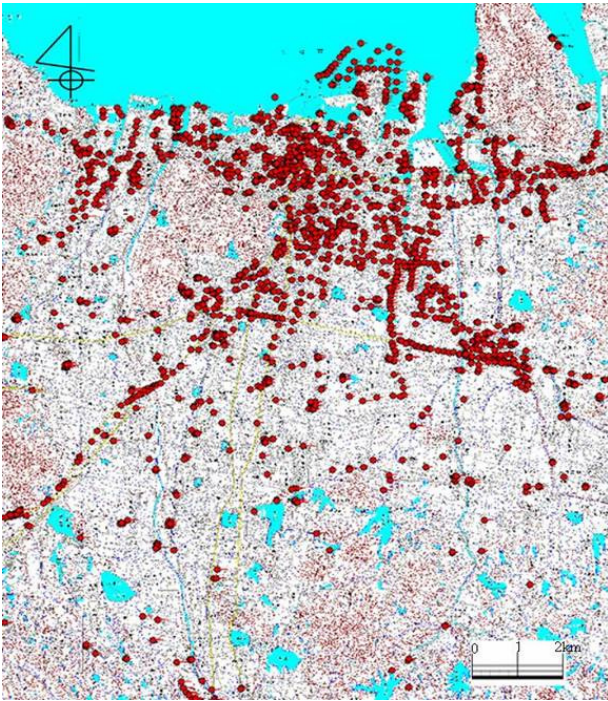
Figure 9. Locality of borehole logs in Takamatsu plain

Figure 9 shows the locality of borehole logs used to prepare database of Takamatsu area. Many borehole logs data are distributed around urban area and national highways include seashore. By the cooperation of public institutions such as Ministry of Land, Infrastructure and Transport and Takamatsu City Office, registered was possible to collect boring data have reached about 1,500.

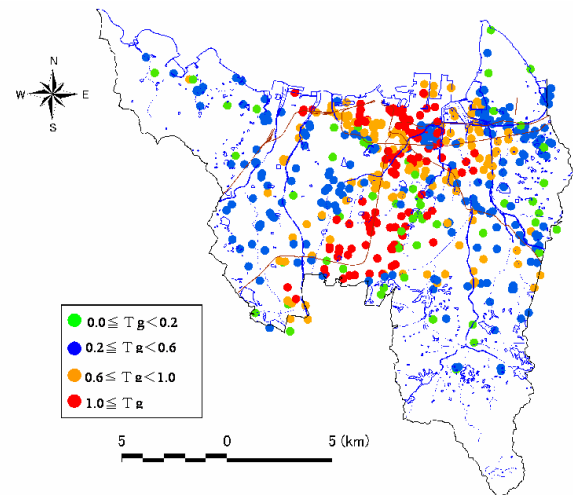
Figure 10. Distribution of predominant period in Takamatsu Plain

The microtremor has been observed at about 400 points in Takamatsu plain (Figures 10 and 11). The predominant period of the ground (T_g) is estimated by the period of the maximum ratio of the H/V spectrum. The ground is divided into three types by the predominant period (Table 2).

Figure 10 suggests an interesting fact that long predominant period of the Koto River fan is originated from thick Quaternary sediments. Thickness of the Quaternary sediments coincides with borehole data.

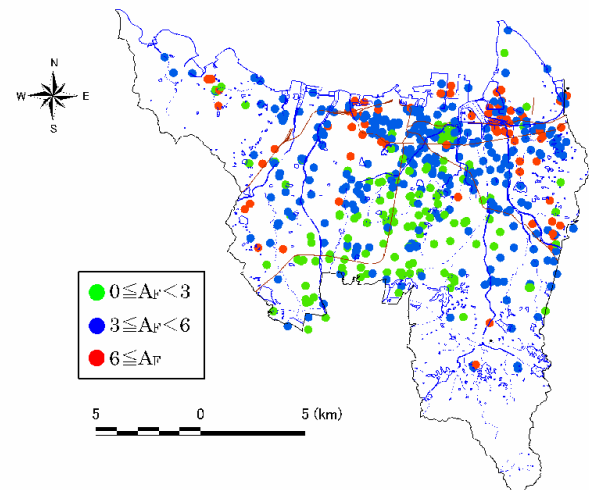
Figure 11. Distribution of amplification factor in Takamatsu Plain

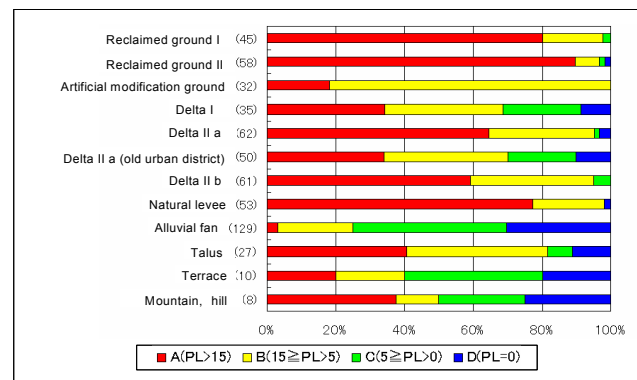
Figure 12. Liquefaction risk of micro-topographic zone

The liquefaction hazard map of Takamatsu city for the Type-I earthquake is shown in Figure 13. The study area is divided into grids of 200m in width. In the case of several borehole logs or result of different liquefaction risk estimation in grid, the highest P_L -value is adopted (Figure 12). The grids which do not have borehole log are considered as area of highest rate of liquefaction risk in each micro-topography. This map suggests that risk of liquefaction is very high at area like reclaimed land, delta in north of Takamatsu plain and flood plain along the Shin and Kasuga rivers.

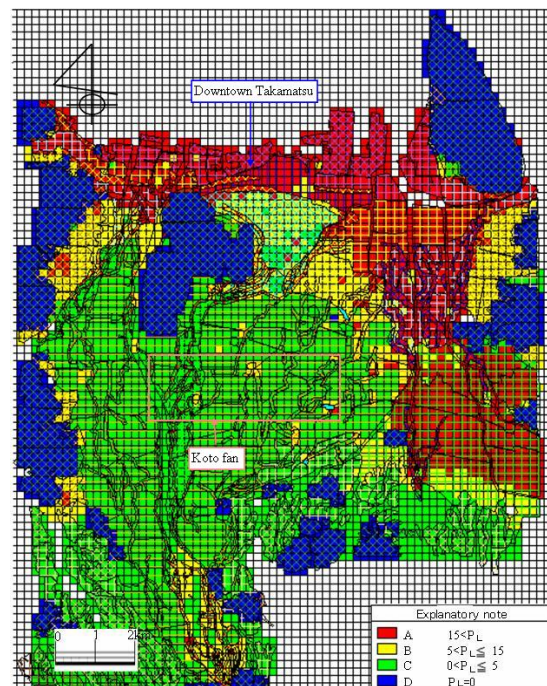
Figure 13. Liquefaction hazard map of Takamatsu city for the Type-I earthquake

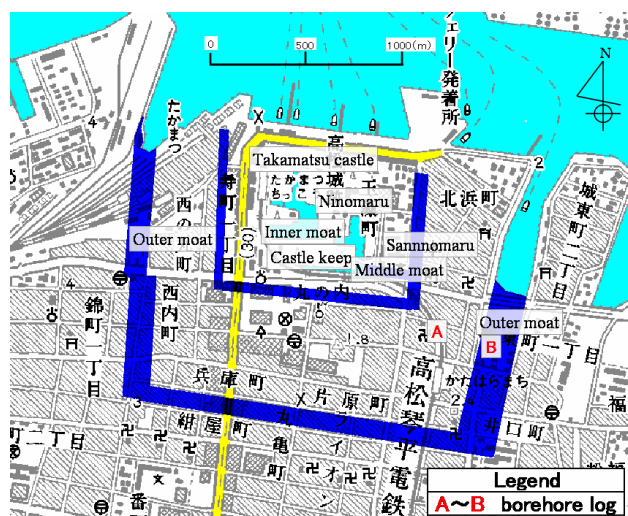
Figure 14. Locality of filled-up moats in the center of downtown area (Kagawa History Museum)

Local ground conditions are very important for estimating seismic hazards. At the center of downtown, old moats of Takamatsu castle had been filled-up and have been used for commercial area. Figure 14 shows the locality of filled-up moats from Kagawa History Museum. The borehole logs indicate that filled-up moats are very weak and can be liquefy easily (Figure 15).

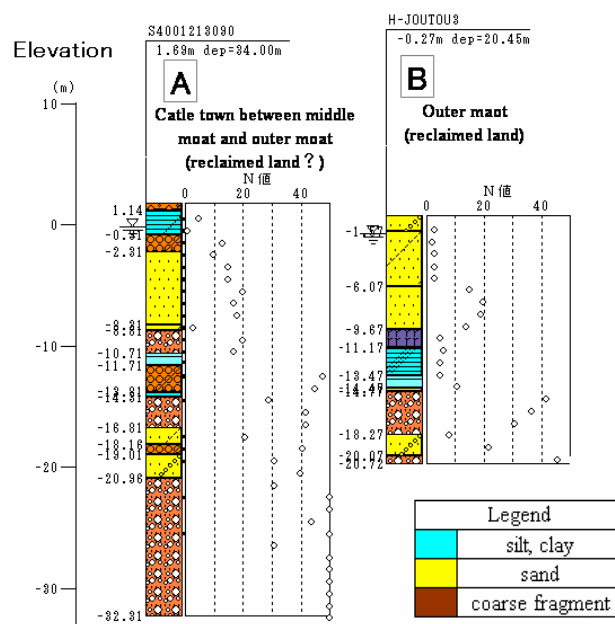
Figure 15. Borehole logs of filled-up moats in the center of downtown area
